AERIAL FLARE SURVEY & INSPECTION

Activity: Aerial Inspection of Flare Stack and Tip

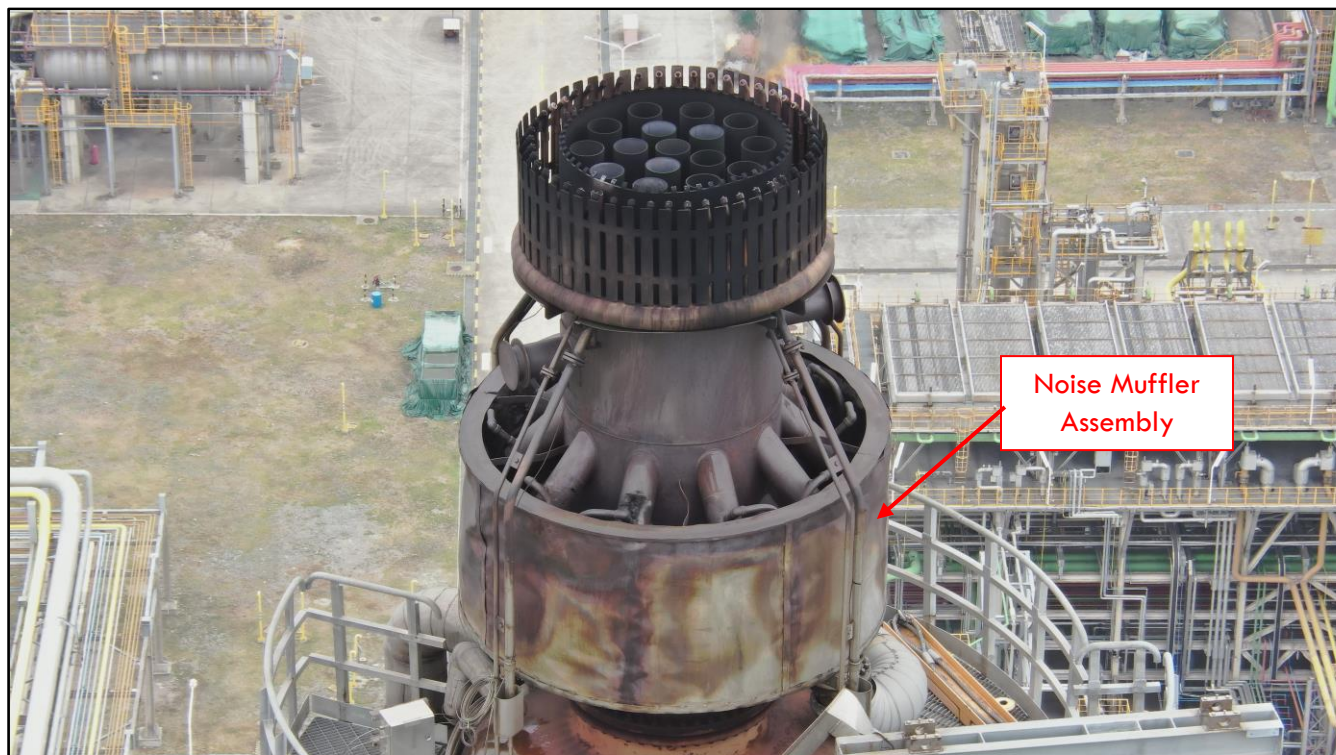
Heavy discoloration and significant heat deformation of the muffler assembly presents evidence of significant internal flame stabilization. The internal flame stabilization has damaged the flare tip muffler, steam tube penetrations, and steam tubes. Smokeless performance of the flare tip is degraded. The flare tip is compromised and should be replaced at the next maintenance opportunity. The flare tip is not fit for long term continued service. Continue to monitor the flare tip closely for further degradation.

FIGURE 02 – Flare tip assembly should be replaced at the next opportunity. Significant internal burning has occurred in the flare tip noise muffler, smokeless capacity has been compromised, only (1) pilot is functioning, and no combust is occurring.

1. Replace the flare tip and pilots as soon as possible.
2. Ensure flame front generator fuel gas is shut off unless actively igniting flare pilots.
3. Improve the quality of steam sent to the flare tip and consider heat tracing steam lines.
4. Ensure flare system is being operated at the minimum flare gas and steam purge rates per manufacturer requirements.

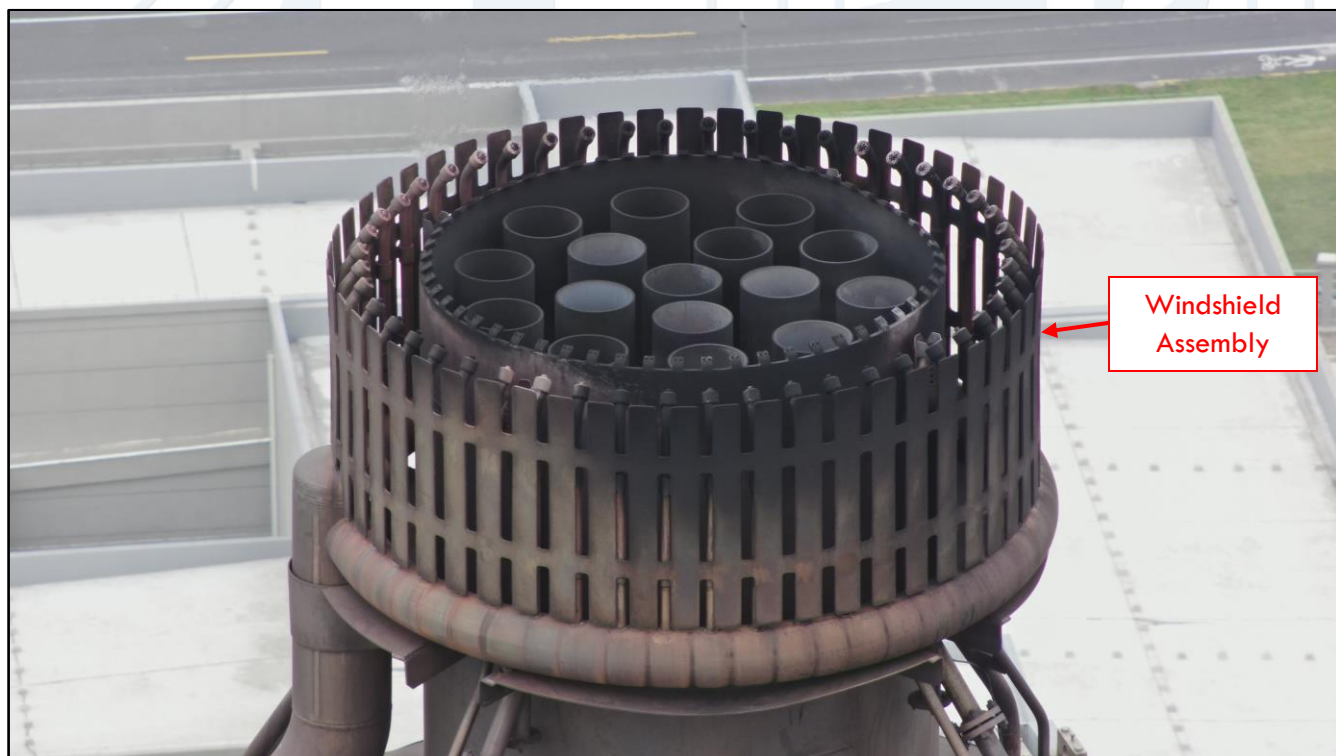
FIGURE 03 – Perimeter steam injection appears to be in fair condition. No deformation is detected on the upper flare tip barrel. Soot deposits are observed on the windshield assembly.

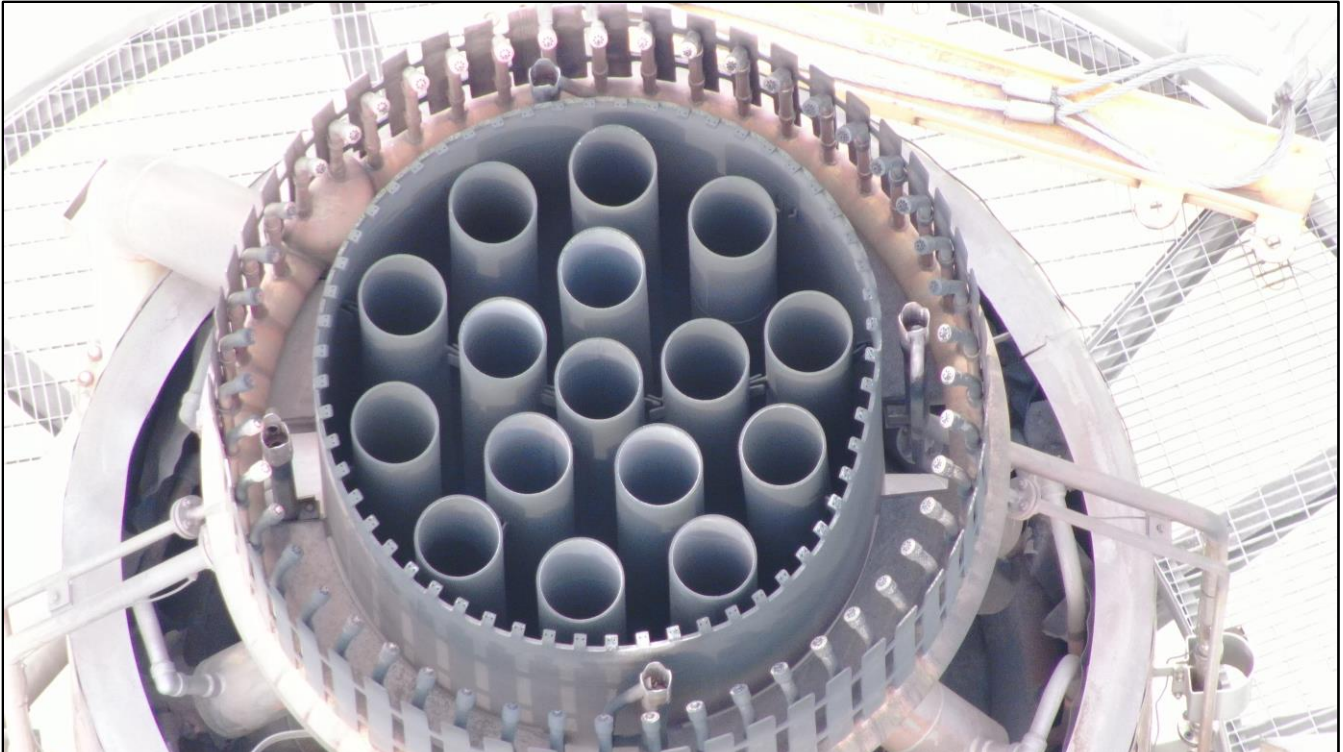
FIGURE 04 – Perimeter steam injectors, steam tubes, flame tabs and pilots all appear to be mechanically intact from an overhead view. The flare tip exit does not appear to have experienced significant heat or combustion, which is an indication that venting has been occurring.

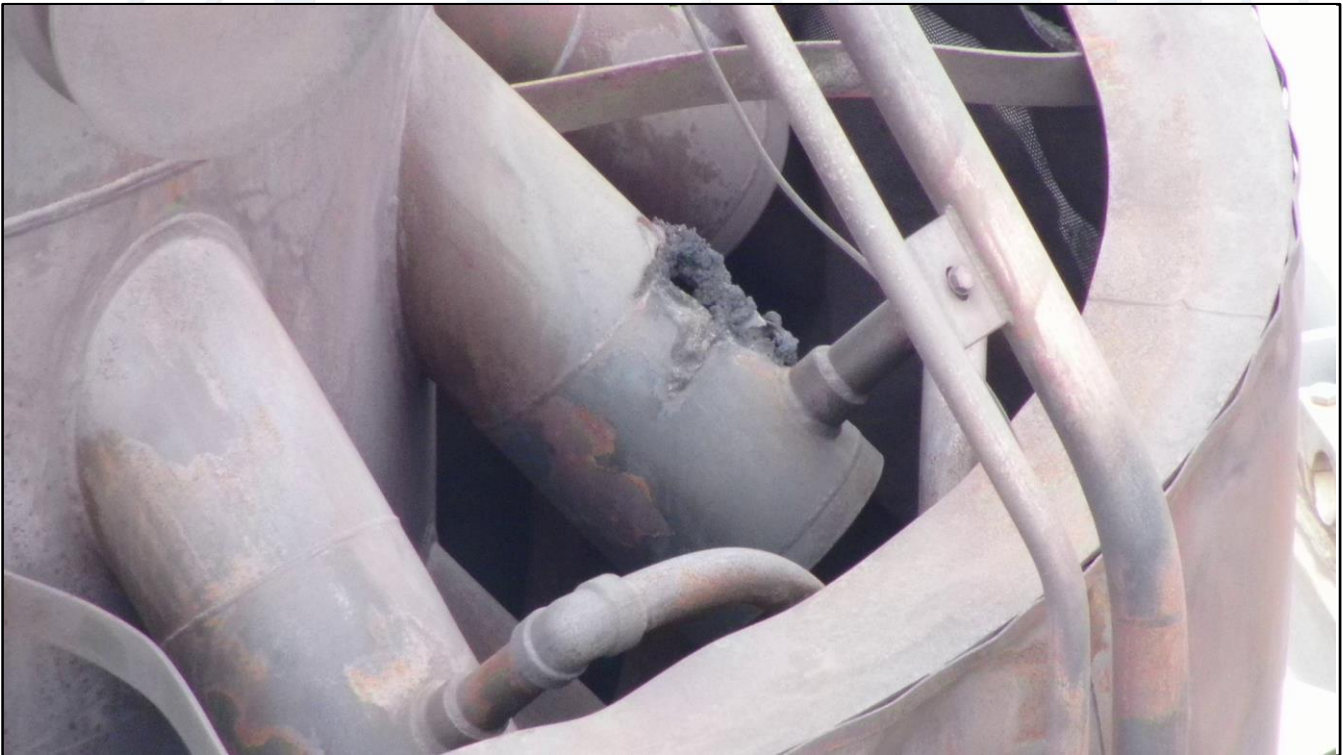
FIGURE 05 – A hole was detected in the steam tubes. Smokeless capacity has been compromised.

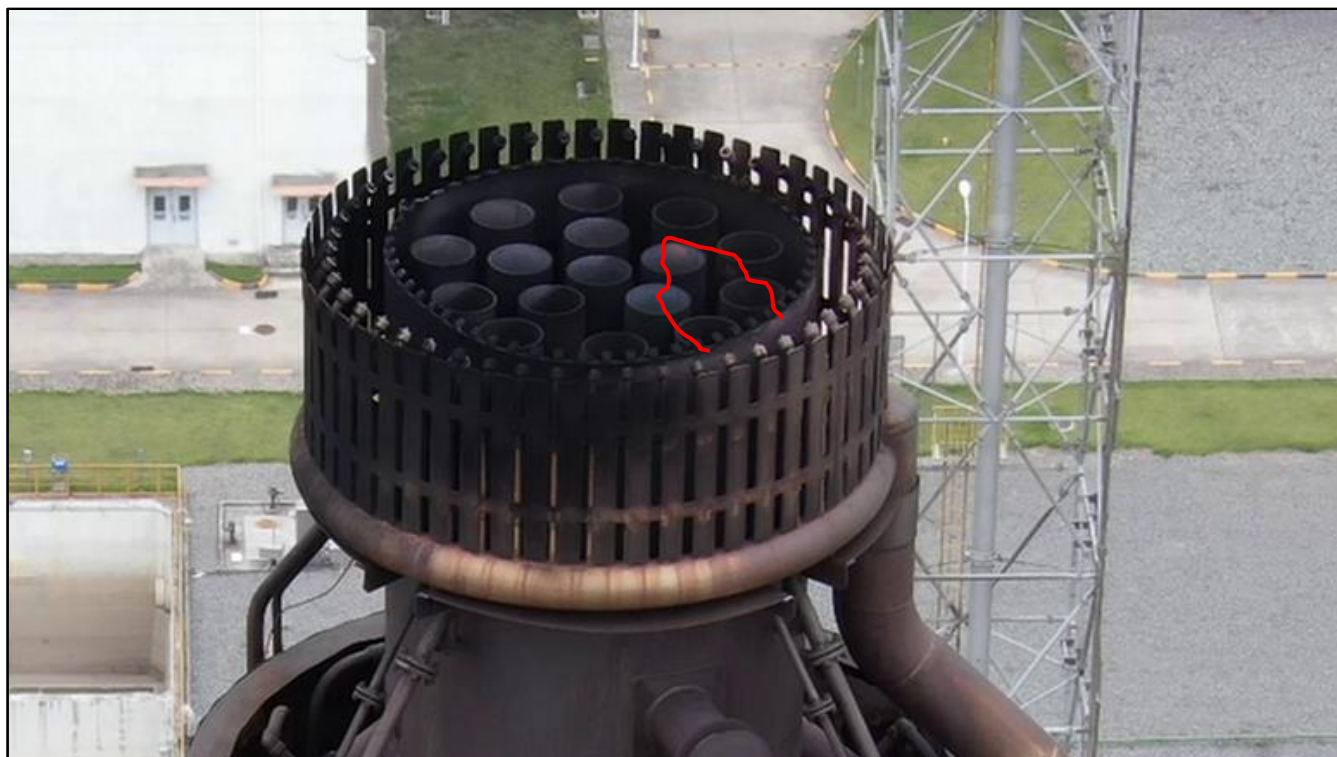
FIGURE 06 – Only (1) pilot appears to be working, and a long yellow flame is seen exiting from the pilot tip. Pilot flame should be blue in color and contained within the pilot hood. This operation indicates pilot instability. Ensure Flame Front Generator (FFG) fuel gas and air is shut off unless pilot ignition is occurring.

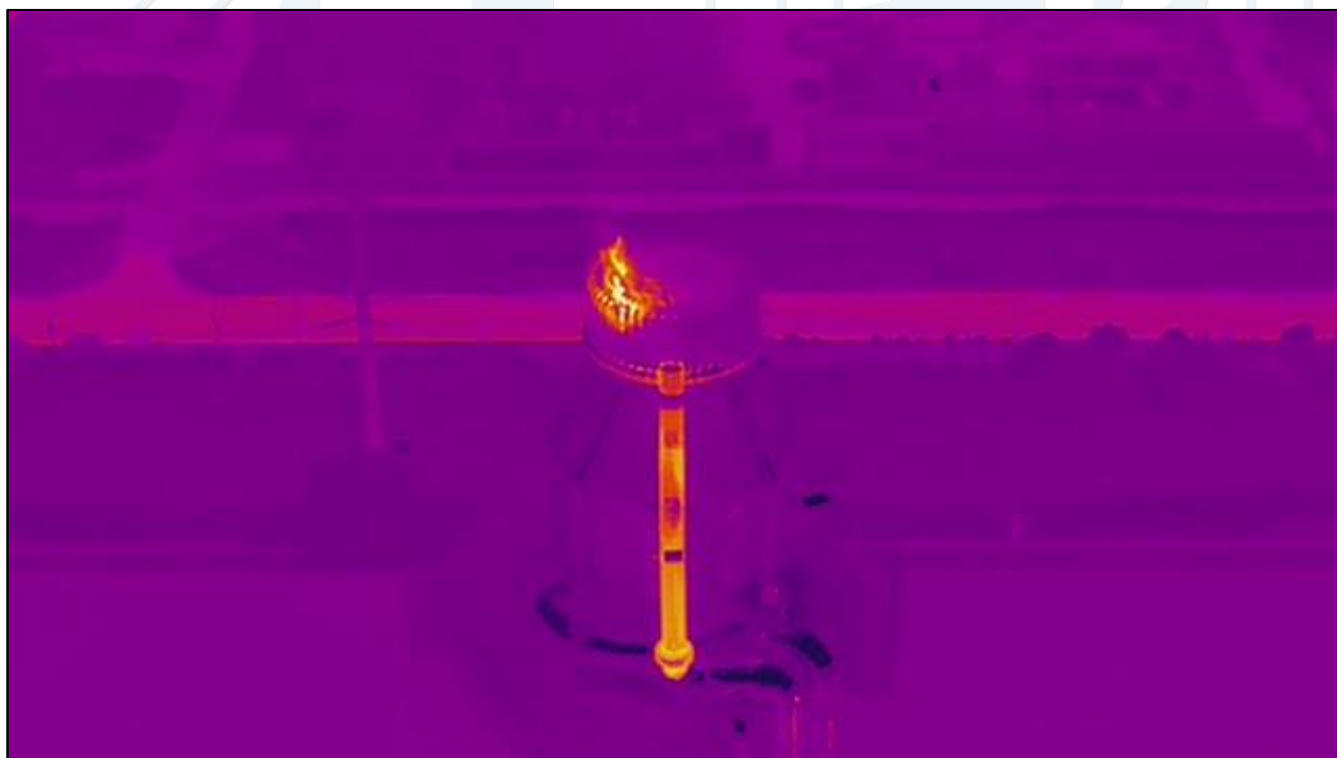
FIGURE 07 – Infrared imagery does not detect any combustion coming from the flare tip. Only (1) pilot shows combustion. Remaining pilots are not lit, and any gas running to the flare system is venting.

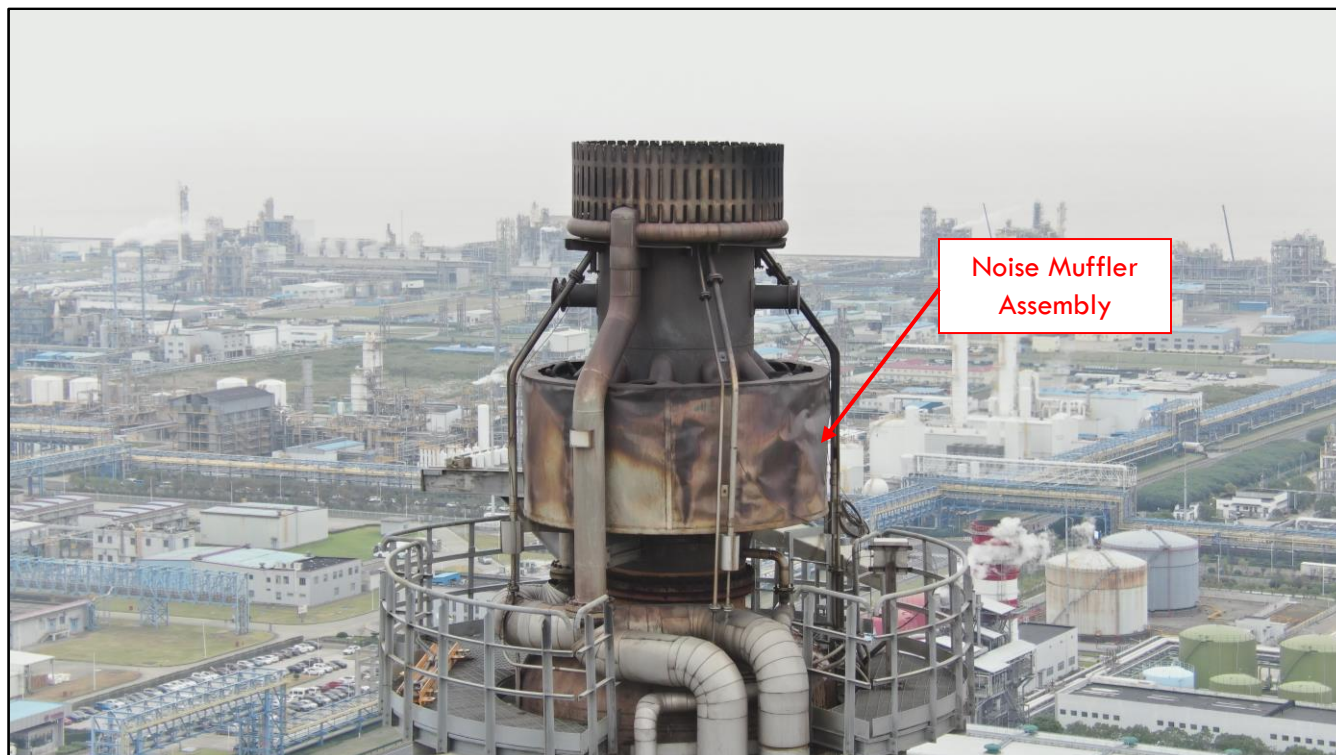
FIGURE 08 – Internal burning has occurred in the noise muffler due to flashback in the steam tubes. This indicates breakage in steam tubing, and a lack of continuous steam flow. Continuous flow is required through steam injection components to provide cooling and prevent flashback. Ensure continuous cooling steam is run to the flare tip per manufacturer recommendations.

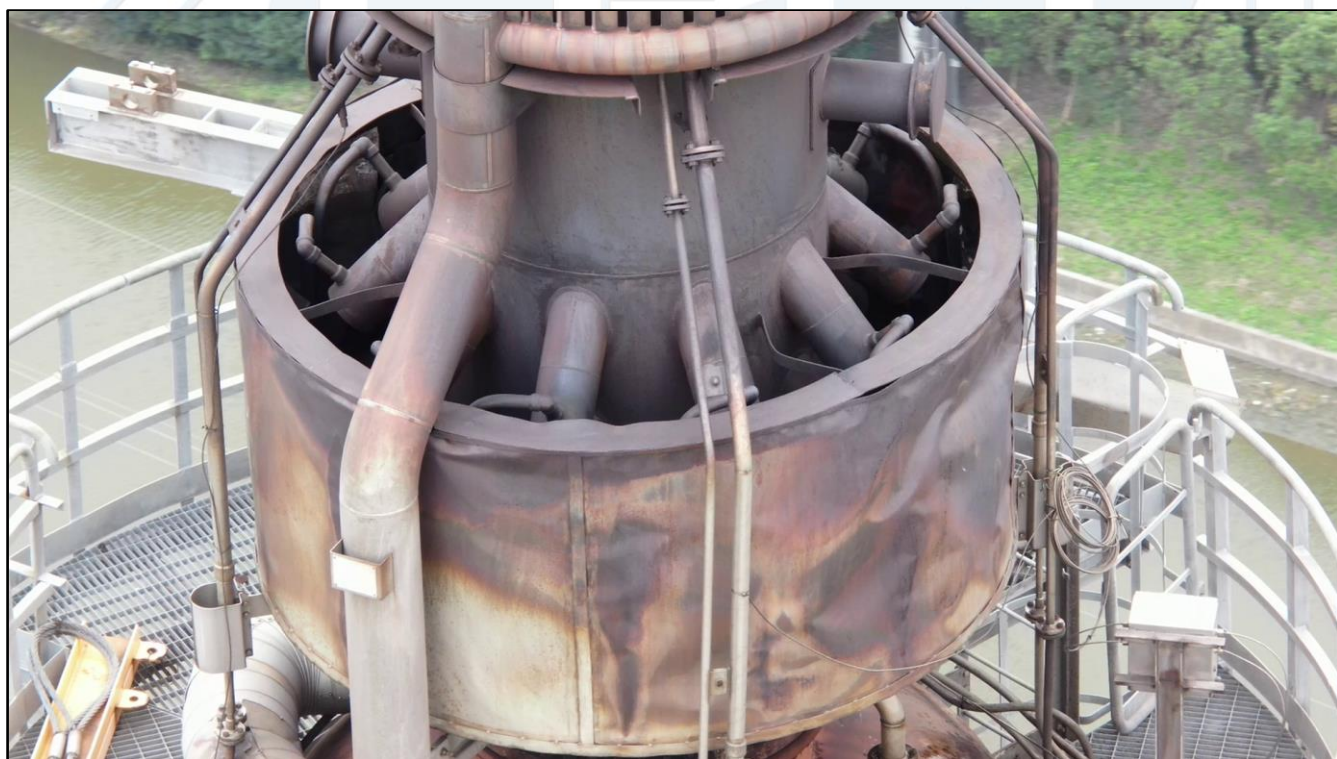
FIGURE 09 – Thermocouples are directly exposed in the heat affected zone. Zeeco recommends running thermocouples in tubing or conduit to prevent failure.

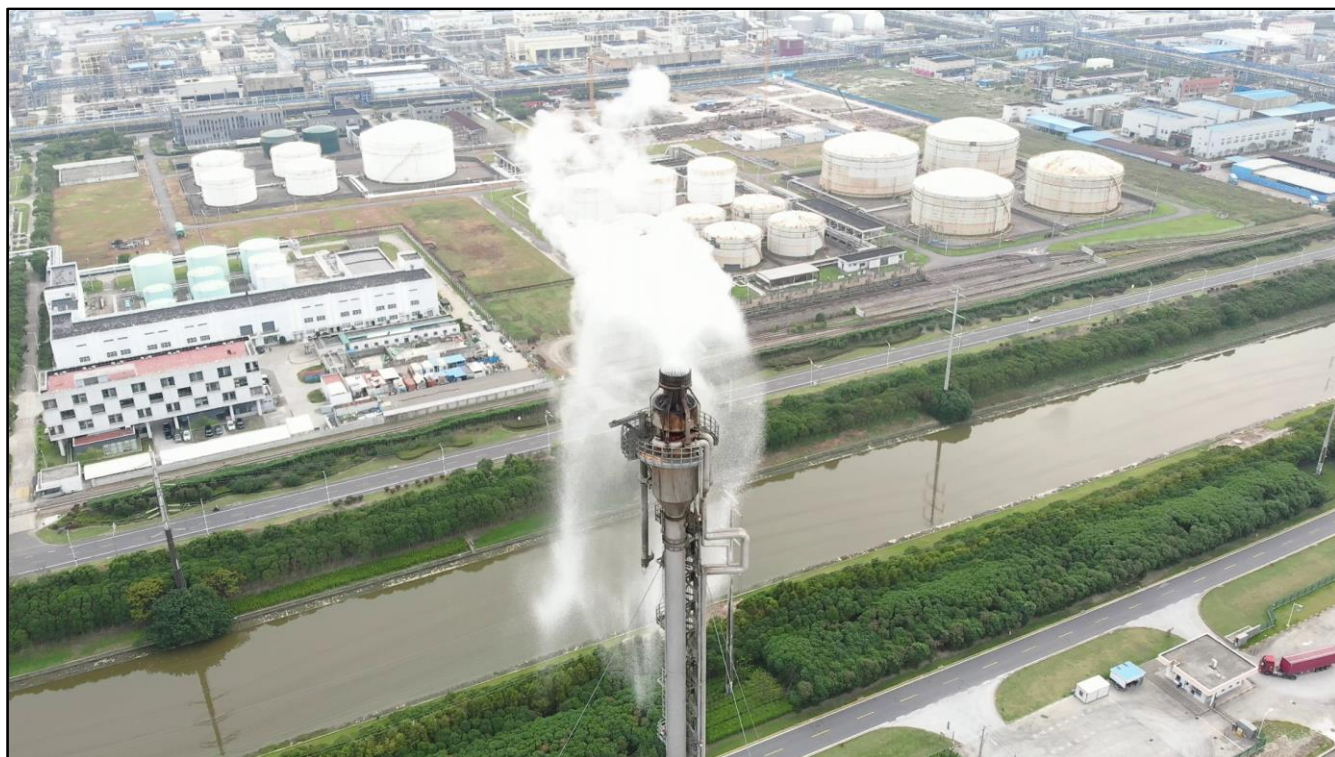
FIGURE 10 – When steam rate was increased, a significant amount of water exited the steam injectors. Zeeco recommends improving steam quality to improve smokeless performance and extend the lifetime of steam injection components. Another option to consider is heat tracing steam risers.

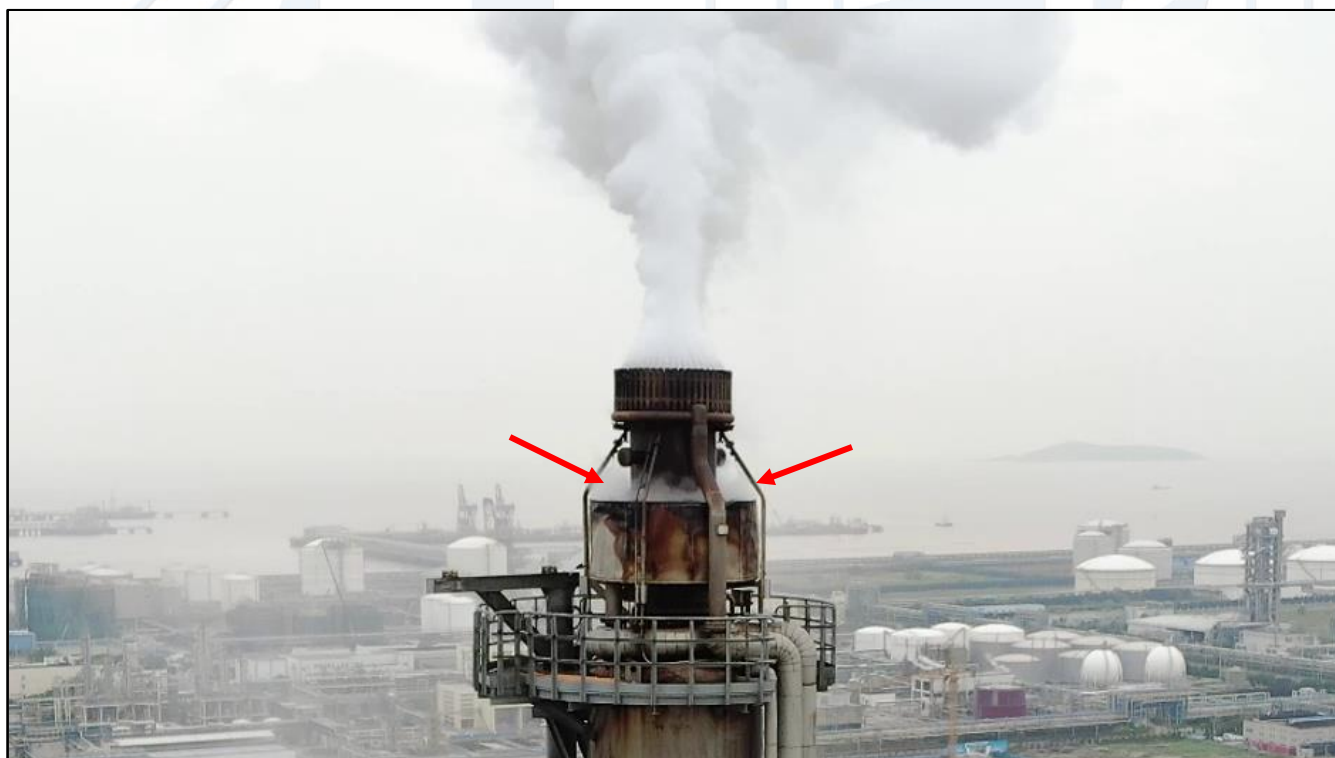
FIGURE 11 – Steam condensation exiting the noise muffler; this indicates breakage in steam tubes. Smokeless capacity has been compromised, and there is the potential for tubes to break apart and fall into the molecular seal assembly.
