Vol. 168 • No. 12 • December 2024

## Replacing Duct Burners in Combined Cycle Power Plants

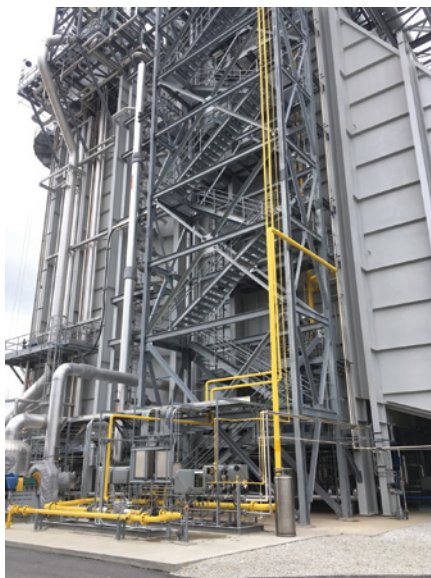
1. A typical combined cycle power plant duct burner system. Courtesy: Zeeco

This case study of one such turnkey duct burner system (Figure 1) replacement performed by Zeeco helps facility owners understand the pathway from diagnosis to start-up and demonstrates the benefits of eliminating aging equipment from a power plant's infrastructure.

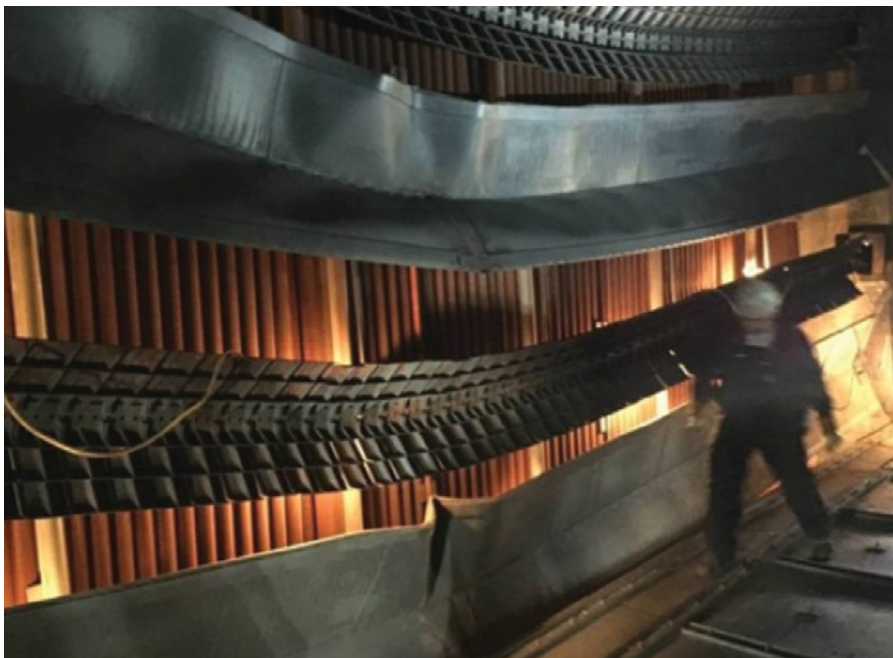
The inability of the pilot to light off the main fuel flames can result from sagging burner elements. Additional causes for this failure are simply the destruction of the sparking device(s) that reside inside the HRSG furnace environment day after day at extreme temperatures. The general electrical circuitry of high-energy ignition systems is easily disrupted by water vapor from the TEG and open conduit systems, which can often be soaked with stormwater. In this case, the sagging of the burner element was the primary cause of the pilot's failure to light the main fuel. The sparking tips were no longer in the pathway of the main fuel and never stood a chance to light.

2. This image shows sagging that is typical in older duct burners. Courtesy: Zeeco

However, as the burner tips erode under fuel pressure over time, or flame stabilizers warp due to recirculation of TEG flow and burner flame, or as burner elements sag (Figure 2), the fuel is allowed to flow further downstream of the burner tip before actual or complete combustion takes place. These factors can enable flames to grow longer until they impinge on the tubes. Over time, impingement will destroy the tubes. This issue must be corrected or future failure is imminent. In this case, longer flames caused by eroded burner tips contributed to flame impingement.

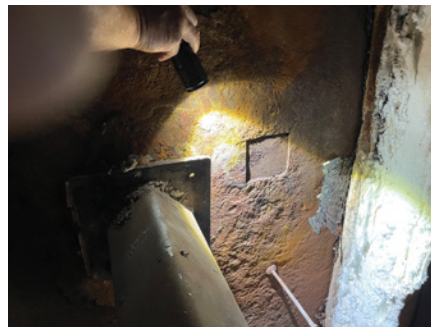
3. This image shows corrosion on the casing wall of the heat recovery steam generator. Courtesy: Zeeco

Nearly all turnkey installation projects produce some discovery that identifies unknown issues before the start of demolition of the existing equipment. In the case of this project, the discovery was serious internal corrosion to the HRSG carbon steel casing walls (Figure 3). This type of discovery is increasingly common for older HRSG and duct burner equipment, specifically when HRSG units are originally installed near marine environments, or in places where temperature extremes may cause the exposed casing, enclosed HRSG wall insulation, and the HRSG internal floating liner plate system to work extraordinarily hard.

Other common discoveries for these types of HRSGs and duct burners are internally corroded fuel piping, reduced wall thicknesses of the pressure piping, and valve seat corrosion or destruction. These issues develop over time due to varying fuel temperature fluctuations throughout the plant's fuel piping infrastructure caused by changing weather and seasonal conditions. The external piping was already scheduled for replacement for this project with new corrosion-free piping, fittings, and valves.

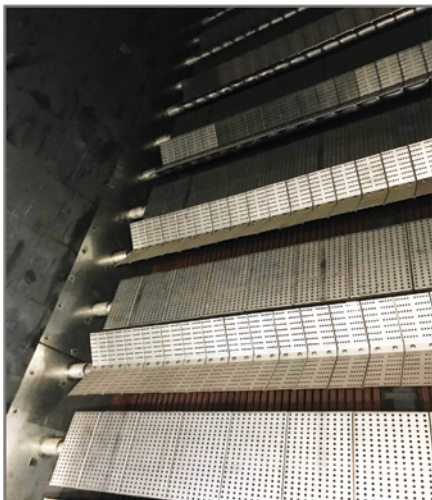
4. This is a look at the completed retrofit of the duct burner system. Courtesy: Zeeco
