A CASE STUDY IN ENGINEERING, EXPERIENCE, AND EXPERTISE

Reverse Engineering Cuts Costs & Corrosion

Texas Gulf Coast

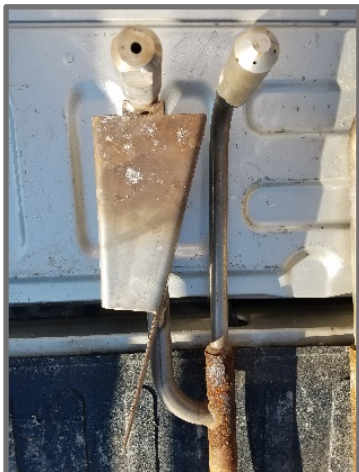
Competitor Part

A large chemical plant on the Gulf Coast needed to replace tip and riser components of multiple process burners operating in an olefins unit due to recurring corrosion issues. The original equipment manufacturer (OEM) offered to supply like-in-kind parts for the system, meaning the chemical plant would be purchasing replacements with the same underlying corrosion issues. Seeking an economical solution to address the problem's root-cause, the chemical plant called on Zeeco to engineer the replacement parts.

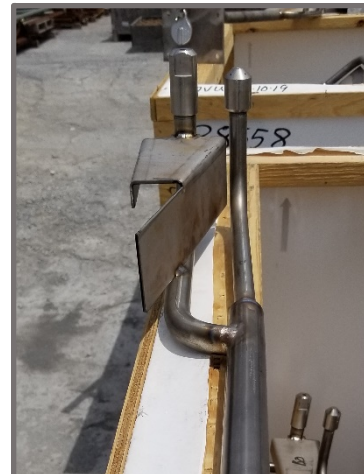
ZEECO® Replacement

To prevent future damage from corrosion, Zeeco's Aftermarket engineering team chose to fabricate the replacement burner tips and risers from stainless steel instead of carbon steel used to make the original components. The team also identified an opportunity to simplify production and reduce manufacturing costs by shortening one of the tips' overall length – moving the threads further from a radius in the riser.

Operators in the chemical plant approved Zeeco's engineered solution. All 120 replacement burner components arrived at the site by the expected delivery date – within six weeks of the order's receipt. The customer has not reported any corrosion issues since the installation of the new risers and tips.
